**Flood Control Project Maintenance
Levee Inspections**

2018 Channel Summary Report

DWR Sutter Maintenance Yard

Big Chico Creek

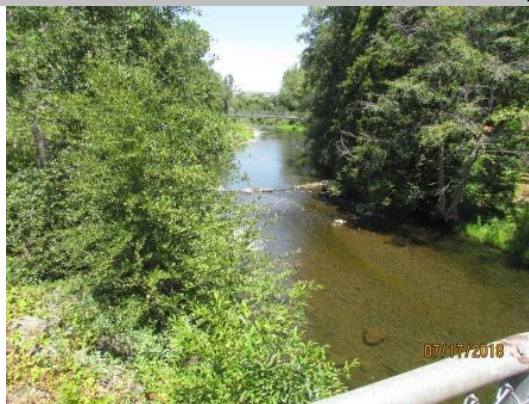
Photo 1 of 1 : CH_2018_NA0060_5_1_20180730_00027.jpg

Rating **	A	Issue No.	1	GPS Lat/Long
Issue Type +	Ma	Location *		39.761840 °
Category	Rivers, Channels & Designated Flood			-121.792590 °
Item	Vegetation & Obstructions			
DWR ID	DWR_NA0060_5_c_2012_1			
Action/Comments				
Inspector Comments: Minimal, scattered obstructions and vegetation. The flow is not impeded.

View of the channel from the structure facing upstream from the structure, 2018.

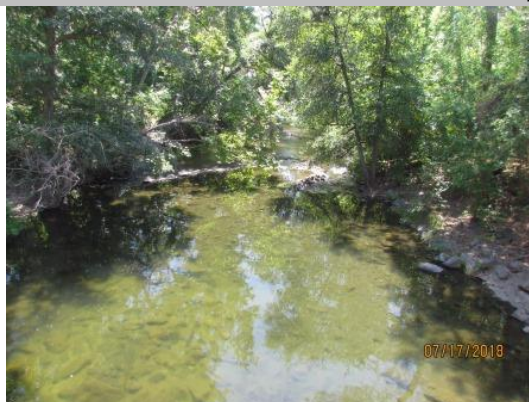
Photo 1 of 1 : CH_2018_NA0060_5_6_20180730_00028.jpg

View of the downstream side of the channel from the structure, 2018.

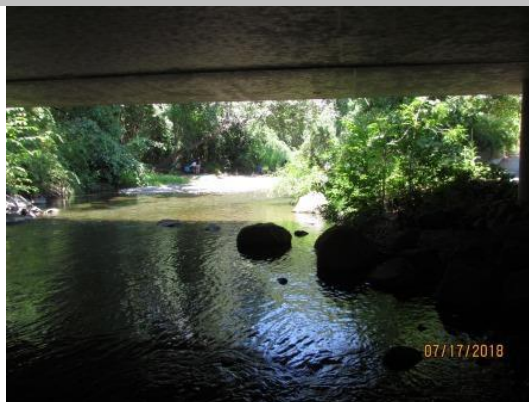
Photo 1 of 1 : CH_2018_NA0060_5_11_20180730_00030.jpg

This photo is looking upstream from under Manzanita Ave, 2018.

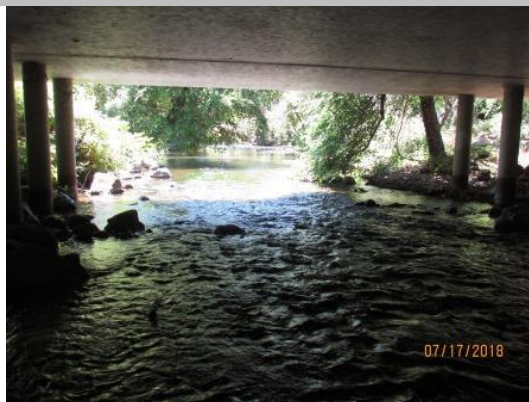
Photo 1 of 1 : CH_2018_NA0060_5_16_20180730_00037.jpg

This photo is looking downstream under Manzanita Ave, 2018.

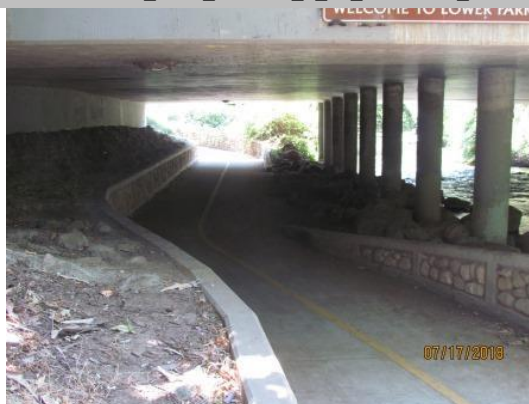
Photo 2 of 2 : CH_2018_NA0060_5_19_20180730_00039.jpg

View looking downstream at the left bank of typical revetment around the abutment, 2018.

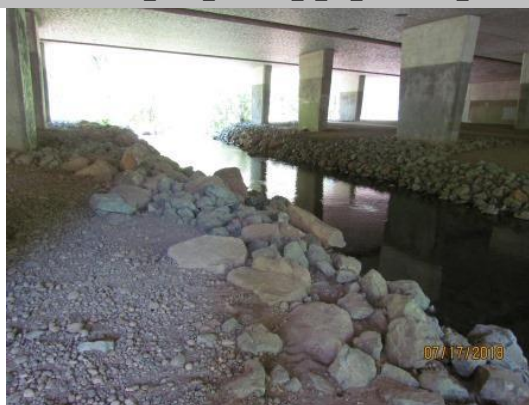
Photo 1 of 1 : CH_2018_NA0060_5_24_20180730_00041.jpg

View of revetment along the channel, looking upstream, 2018.

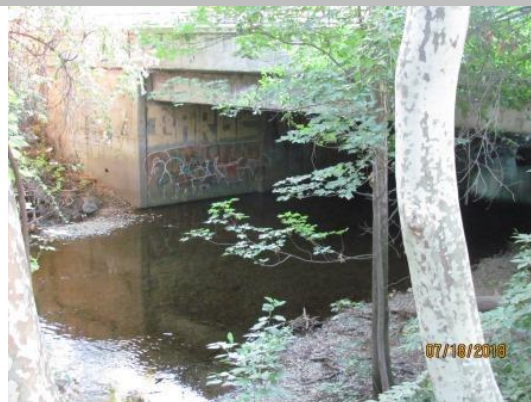
Photo 1 of 1 : CH_2018_NA0060_5_39_20180730_00048.jpg

No revetment present at the bridge abutment, 2018.

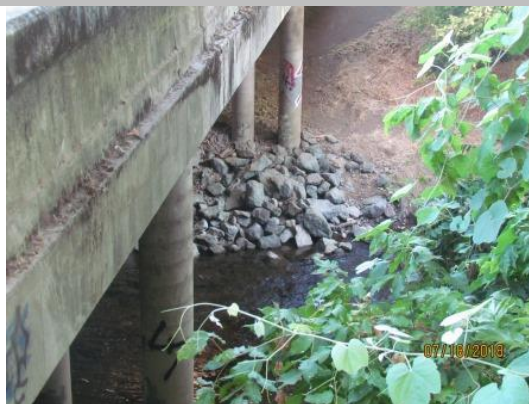
Photo 1 of 2 : CH_2018_NA0060_5_44_20180730_00050.jpg

View of revetment around piers, 2018.

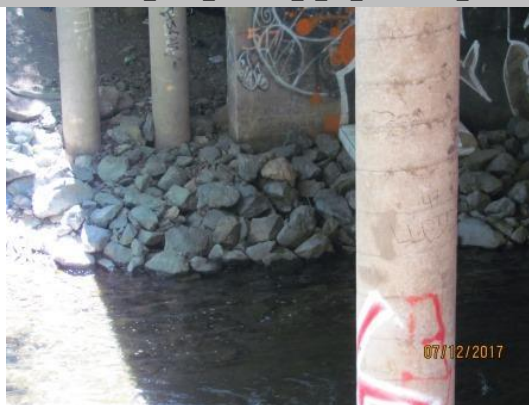
Photo 2 of 2 : CH_2018_NA0060_5_44_20180716_00020.jpg

View of revetment around piers, 2017.

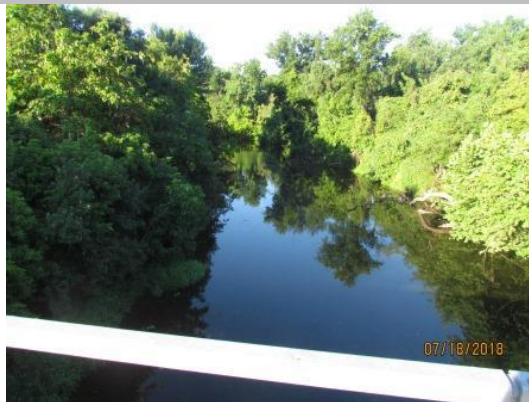
Photo 1 of 1 : CH_2018_NA0060_5_56_20180730_00057.jpg

Rating **	A	Issue No.	56	GPS Lat/Long
Issue Type +	Ma	Location *		39.704580 °
Category	Rivers, Channels & Designated Flood			-121.939320 °
Item	Vegetation & Obstructions			
DWR ID	DWR_NA0060_5_c_2012_56			
Action/Comments				
Inspector Comments: No obstructions observed, the flow is not impeded.

View looking downstream from the bridge, 2018.

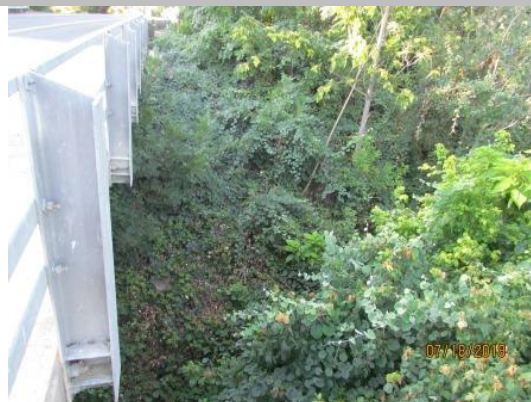
Photo 1 of 1 : CH_2018_NA0060_5_59_20180730_00059.jpg

View of the revetment that is over grown with vegetation, 2018.

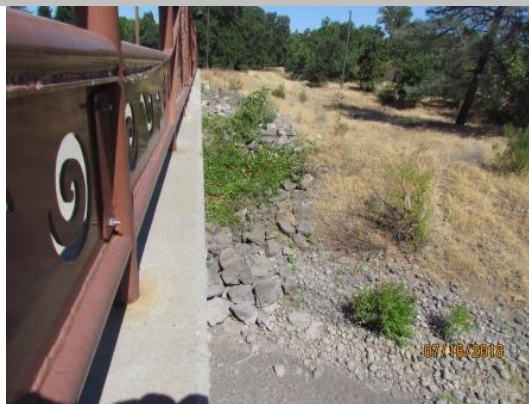
Photo 1 of 1 : CH_2018_NA0060_6_14_20180730_00056.jpg

View of revetment at upstream side of the abutment, 2018.

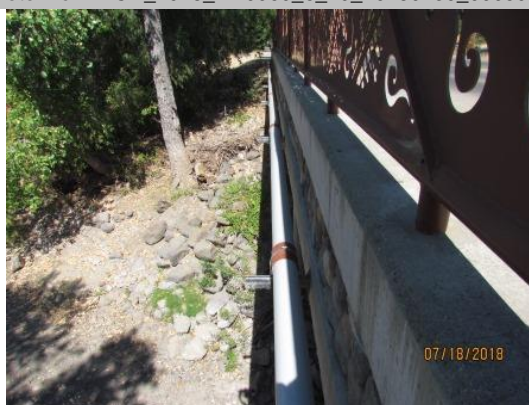
Photo 2 of 2 : CH_2018_NA0060_6_19_20180730_00059.jpg

View of revetment at downstream, right bank side of the abutment, 2018.

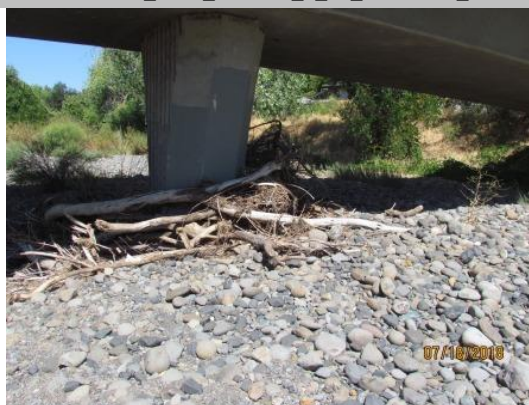
Photo 1 of 1 : CH_2018_NA0060_6_25_20180730_00065.jpg

View of logs and debris accumulated at the center pier of the bridge, 2018.

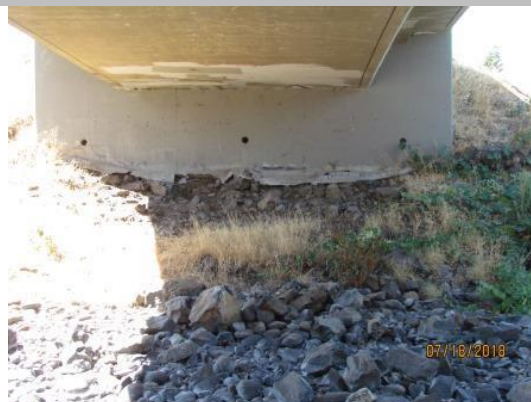
Photo 1 of 2 : CH_2018_NA0060_6_29_20180806_00115.jpg

View looking towards the left bank abutment at missing revetment, 2018.

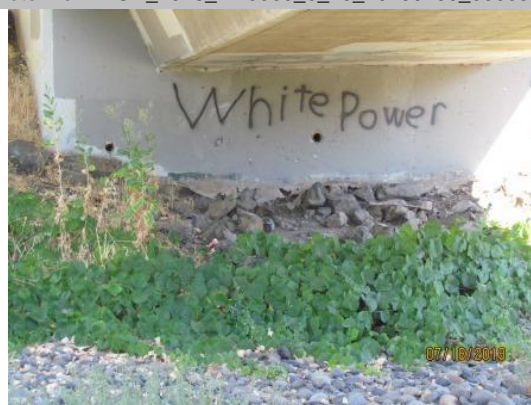
Photo 2 of 2 : CH_2018_NA0060_6_29_20180730_00068.jpg

View looking at the right bank abutment very little revetment remaining , 2018.

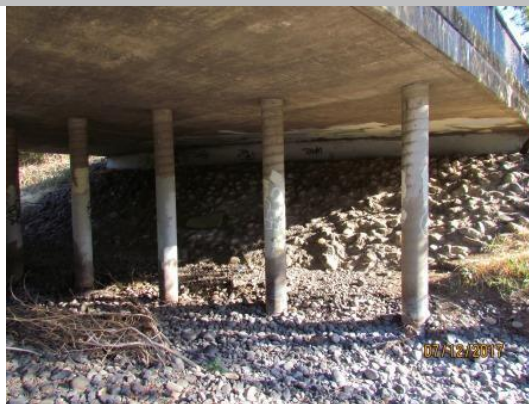
Photo 1 of 1 : CH_2018_NA0060_6_39_20180716_00016.jpg

View looking at left bank, revetment on slope up to the bridge abutment, 2017.

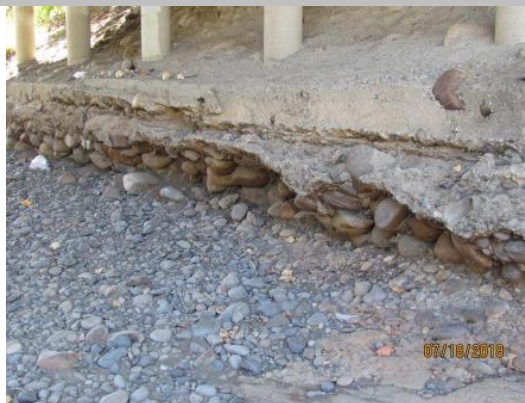
Photo 1 of 1 : CH_2018_NA0060_6_43_20180730_00074.jpg

View of the erosion found under the bridge, 2018.

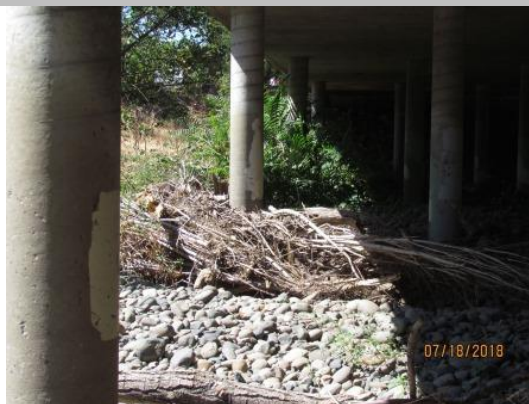
Photo 2 of 3 : CH_2018_NA0060_6_50_20180730_00079.jpg

View of debris, limbs, and trees that have piled against the piers of the bridge, 2018.

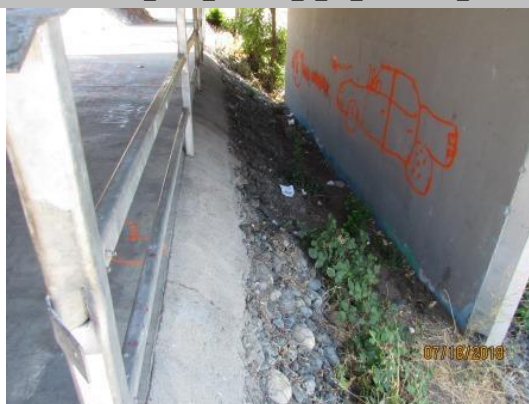
Photo 2 of 2 : CH_2018_NA0060_6_94_20180731_00086.jpg

Revetment on the right bank from the channel to the bike path and to the abutment, 2018.

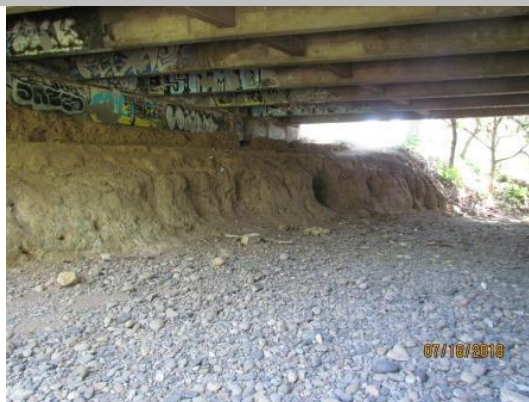
Photo 1 of 1 : CH_2018_NA0060_6_114_20180731_00090.jpg

View looking upstream at the right bank abutment, no revetment observed, 2018.

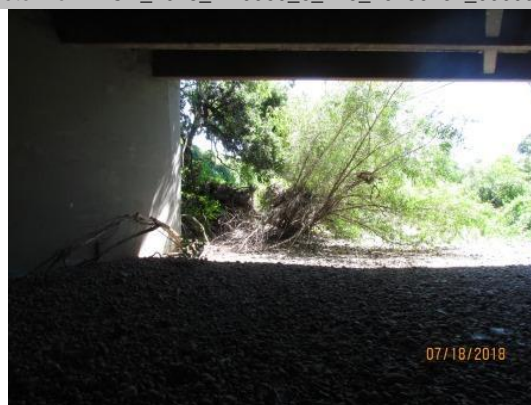
Photo 2 of 2 : CH_2018_NA0060_6_116_20180731_00093.jpg

View looking downstream of debris stuck in trees located in the channel, 2018.

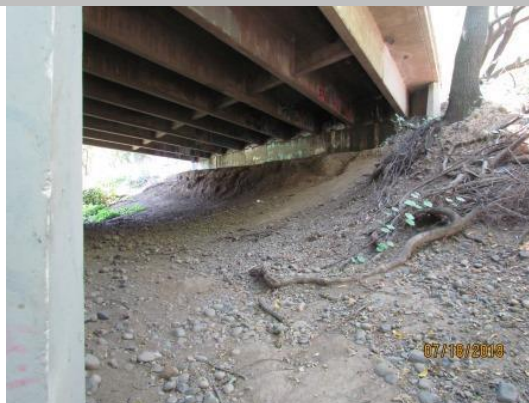
Photo 1 of 1 : CH_2018_NA0060_6_119_20180731_00091.jpg

View looking downstream at the right bank abutment, no revetment observed, 2018.

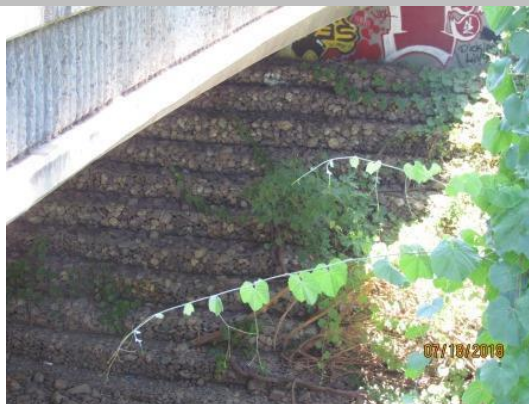
Photo 1 of 2 : CH_2018_NA0060_6_109_20180731_00102.jpg

View of gabion wall revetment at bridge abutment, right bank, 2018.

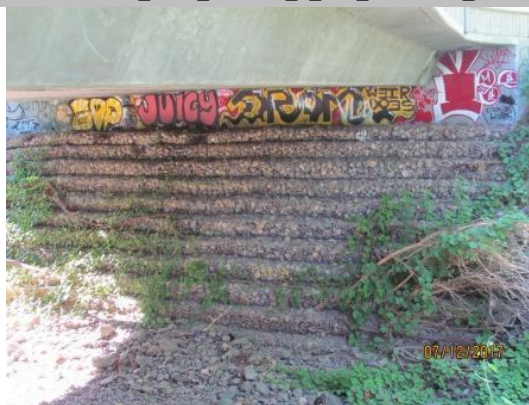
Photo 2 of 2 : CH_2018_NA0060_6_109_20180716_00047.jpg

View of gabion wall revetment at bridge abutment, right bank, 2017.

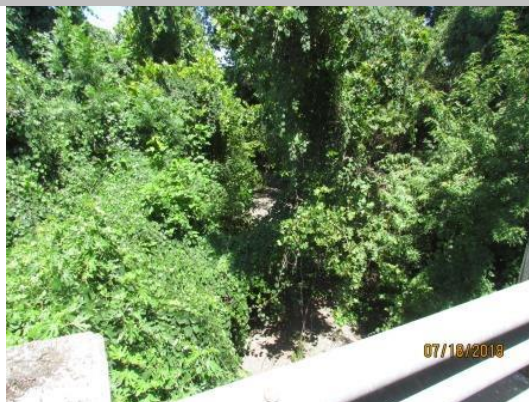
Photo 1 of 1 : CH_2018_NA0060_6_121_20180731_00108.jpg

View of the vegetation looking upstream from the bridge, 2018.

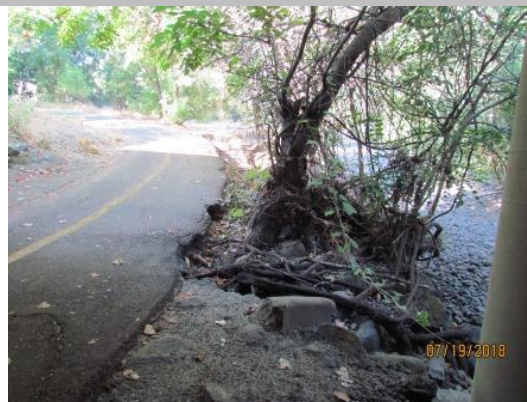
Photo 1 of 1 : CH_2018_NA0060_12_26_20180731_00049.jpg

View of the channel from the under the bridge facing downstream. There is a little debris hung up in the trees, 2018.

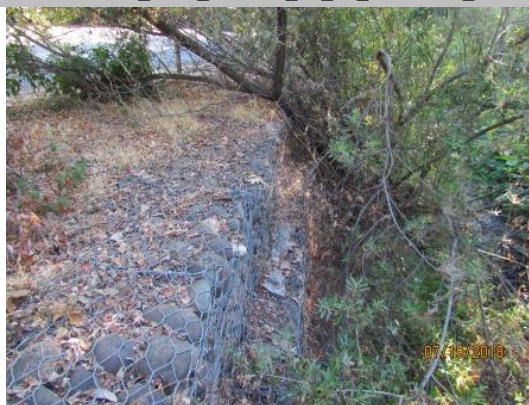
Photo 2 of 2 : CH_2018_NA0060_12_31_20180731_00053.jpg

View of the upstream side of the erosion repair site. The site is approximately 300 yards upstream from the 99 bridge, 2018.

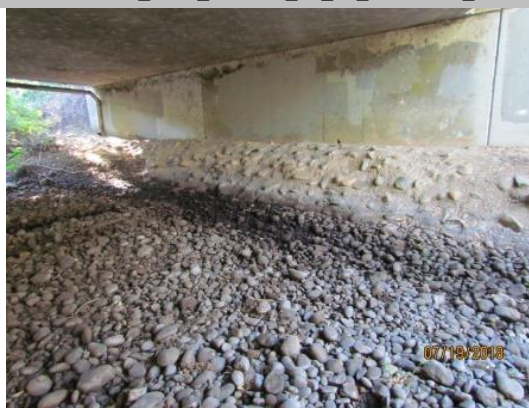
Photo 1 of 2 : CH_2018_NA0060_12_34_20180731_00054.jpg

View of revetment at bridge abutment left bank, 2018.

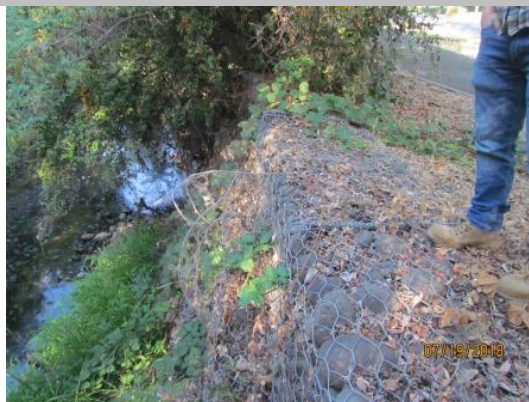
Photo 1 of 2 : CH_2018_NA0060_12_36_20180731_00055.jpg

View looking downstream of the erosion repair site. The repair is approximately 300 yards upstream from the bridge, 2018.

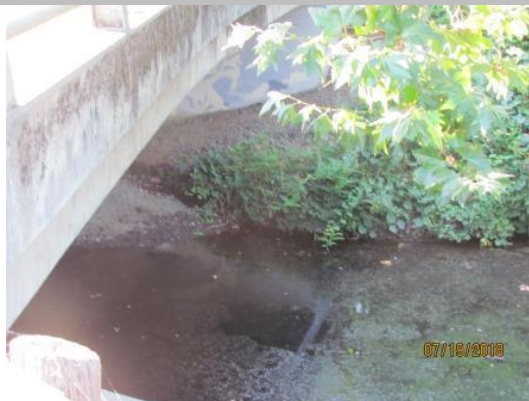
Photo 1 of 1 : CH_2018_NA0060_12_92_20180731_00059.jpg

View of the abutment, no revetment was observed at either side, 2018.

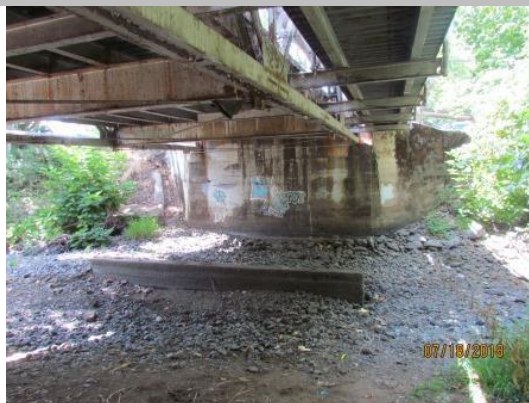
Photo 1 of 1 : CH_2018_NA0060_12_44_20180801_00062.jpg

View of the right bank abutment, no revetment present, 2018.

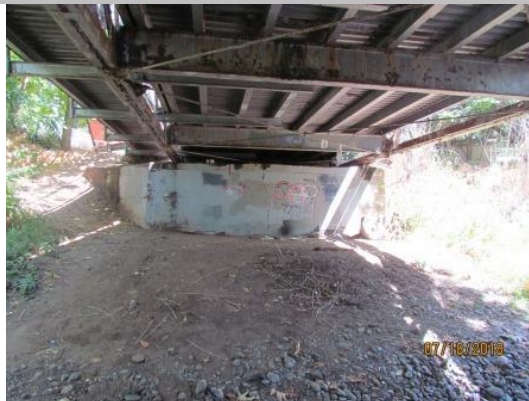
Photo 1 of 1 : CH_2018_NA0060_12_49_20180801_00063.jpg

View of the left bank abutment, no revetment present, 2018.

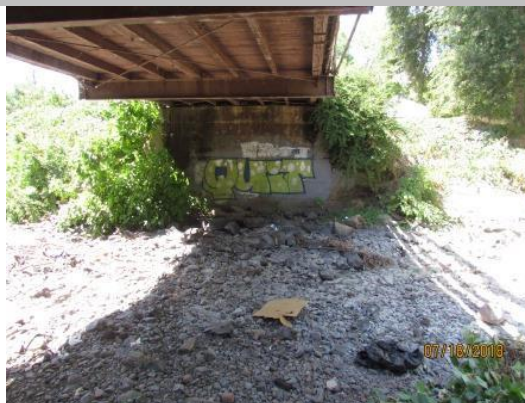
Photo 1 of 1 : CH_2018_NA0060_12_54_20180801_00068.jpg

View of the right abutment, no revetment present, 2018.

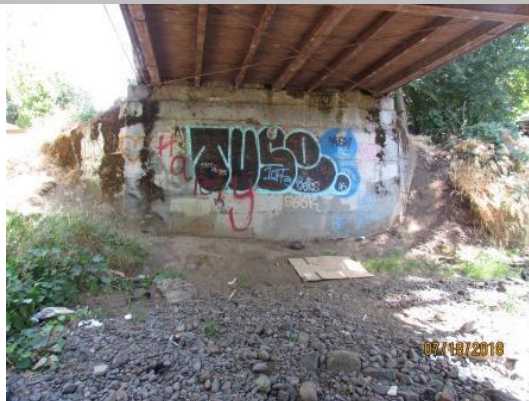
Photo 1 of 1 : CH_2018_NA0060_12_59_20180801_00069.jpg

View of the left abutment, no revetment present, 2018.

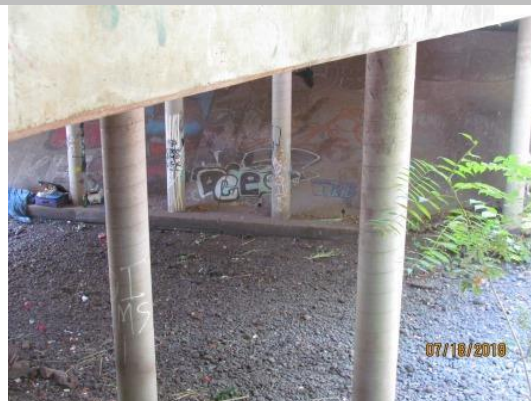
Photo 1 of 1 : CH_2018_NA0060_12_112_20180801_00079.jpg

View of the right bank abutment, no revetment present, 2018.

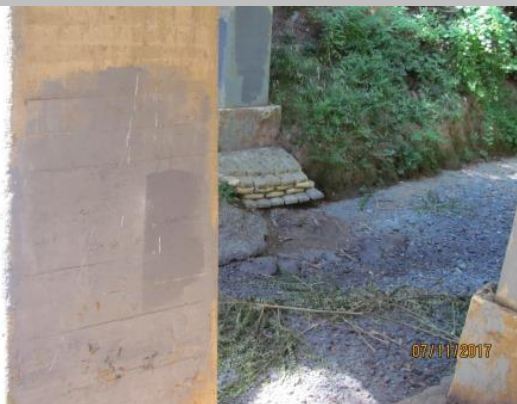
Photo 1 of 1 : CH_2018_NA0060_12_73_20180716_00030.jpg

View of erosion under the sandbag revetment, 2017.

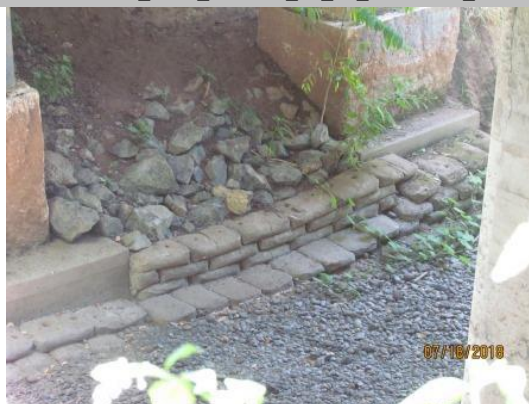
Photo 1 of 1 : CH_2018_NA0060_12_74_20180801_00081.jpg

View of concrete sandbag revetment on the channels edge, 2018.

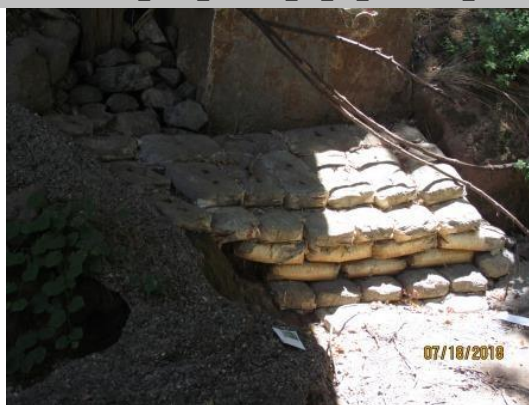
Photo 1 of 1 : CH_2018_NA0060_12_79_20180801_00082.jpg

View of concrete filled sandbags used for riprap at bridge abutments on both sides, 2018.
